City of Leesburg

July 13, 2008

**Reference: Structural Evaluation
Girl Scout Building
Venetian Way, Leesburg, FL**

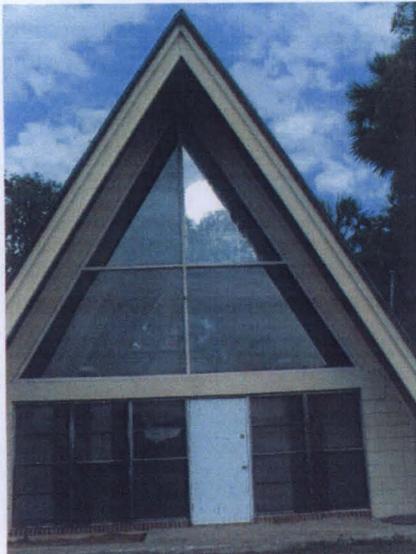
Figure No.1

The structural system of this structure is a series of concrete A-Frames. These A-frames are supported by a continuous concrete footing at each leg. Lateral stability of the A-frames is provided by timber roof panels which span perpendicular to the A-frames. Masonry walls with framed glass form the east and west end of the structure (Figures No.1 & 2).

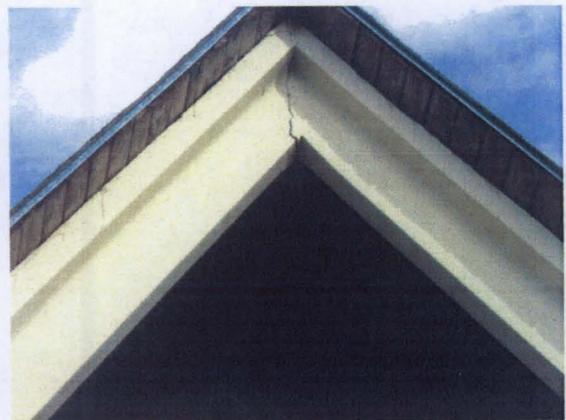
Figure No.3

The top connection of the A-frames have either separated or formed a crack. This anomaly is more substantial in the A-frames on the east end of the structure (Figures No.3 & 4). Step cracks have occurred in the masonry walls on each end. The cracks are more evident on the north side of the east wall (Figures No.4 & 5). Cracks in the floor slab are visible on the north-east section of the structure (Figure No.6). Termite damage was also observed on the timber roof panels.

2. Clean and repair all cracks using a two-component, 100 percent solids, high-modulus, low viscosity epoxy adhesive designed for structural repair.
3. Clean and repair all spalls using a two-component, polymer-modified cementations mortar and shall have a minimum 28-day compressive strength of 7,000 psi.

4. The top connection of the A-frame should be reinforced with a galvanized steel plate on each face. Secure steel plate to concrete frame with $\frac{3}{4}$ inch galvanized bolts.

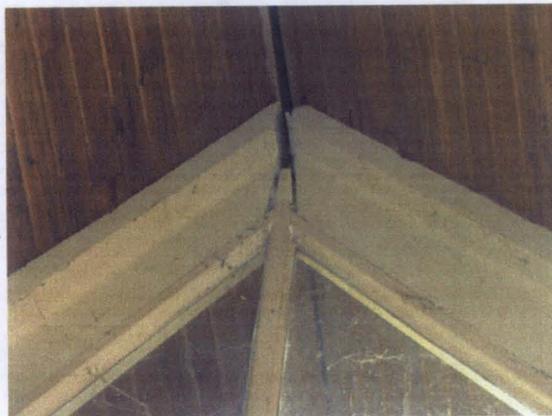
Figure No.7

The separation of the top joint and the step cracks in the masonry wall indicate settlement and /or horizontal movement of the supporting foundation of the A-frame (Figure No.7). This is possibly caused by the poor drainage around the structure, in particular on the north side.

1. Construct reinforced concrete tie-beams across the floor of the building to connect each pair of A-frame leg sections. These tie-beams should be designed to prevent horizontal movement of the continuous footing. The top of each tie beam should be flush with the floor. Partial removal of each wall section and the internal lavatory wall will be required to install these tie-beams..

5. Provide positive drainage away from the structure. As recommended by the geotechnical engineer, permanent measures shall be constructed and maintained to ensure positive drainage from the structure throughout the functional life of the structure.
